GIANT FOREST  
**SEQUOIA**

**A Historical and Architectural Study of  
Three Rustic Structures at Giant Forest in Sequoia National Park  
The Market, District Ranger's Residence, and Comfort Station**

**HISTORIC STRUCTURES REPORT  
SEQUOIA NATIONAL PARK**

Approved  
December 7, 1988

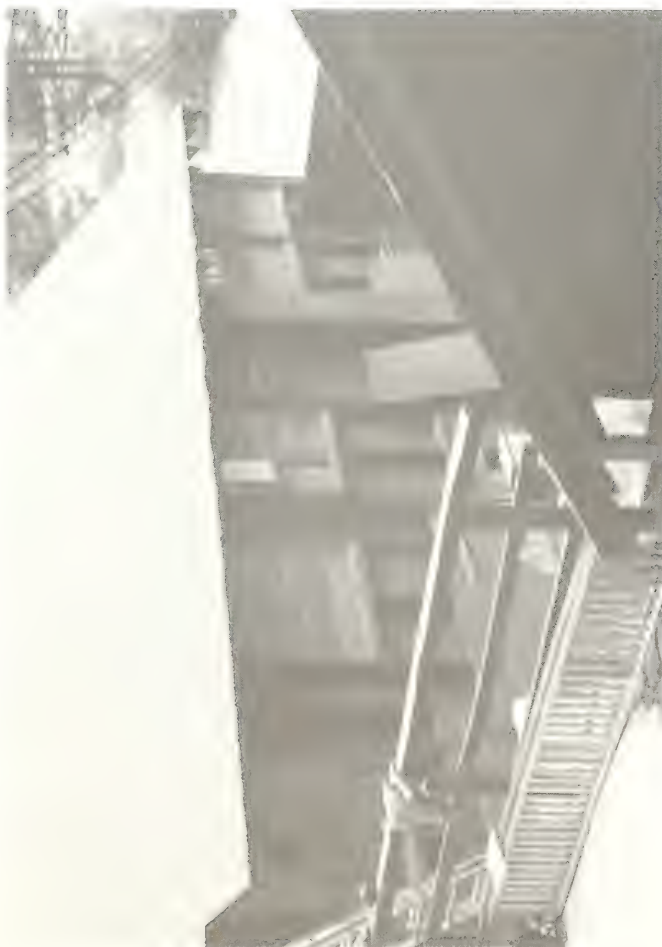
Figure 59 (right). Market, Shed Addition (10/86). The timber frame rhythm of the east elevation of the 1938 shed-roofed addition is, again, entirely compatible with the original building. Wooden panels have been removed, in this view, to expose the windows. Notice the poor condition of the 1975 aluminum sheet roofing. The concrete foundation walls serve as retaining walls and are stepped, following the site contour.

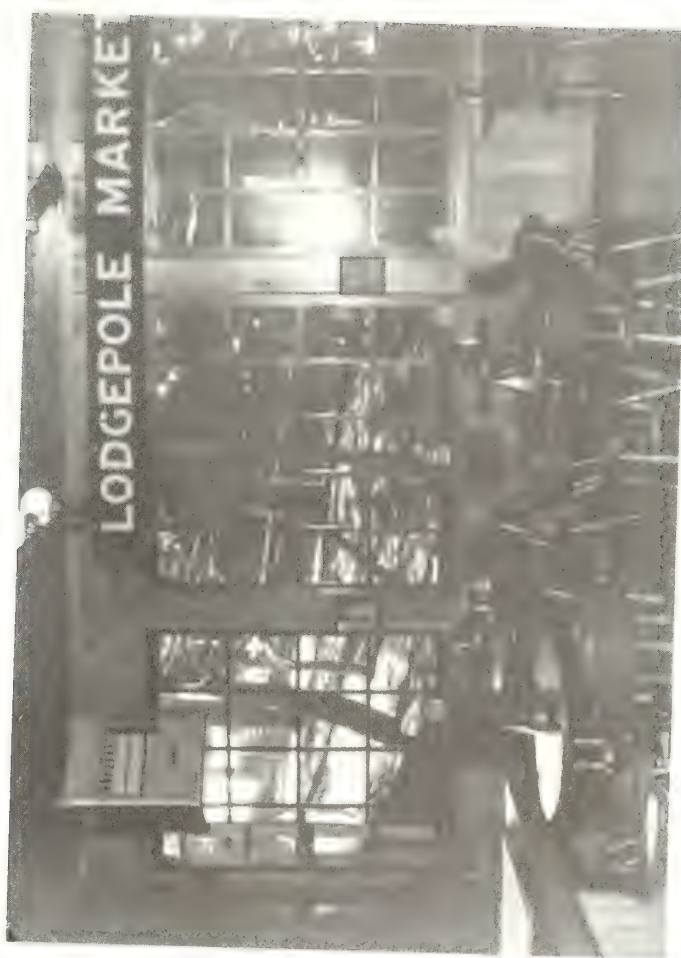
Figure 60 (left). Market, Store Interior (room 101) (5/86). The important impact of the knotty pine on walls and ceiling is clear in this view as is the intrusive and out of character aspect of fluorescent lighting fixtures. The knotty pine was apparently installed in the early 1930s. It is nailed directly to ceiling joists but is firred out against the walls. This view faces north towards room 102.

27) existing lighting is intrusive and incompatible with proposed use <sup>10</sup> (see figure 60)	27) location of systems is unsatisfactory and fluorescent lights are inappropriate for this historic structure

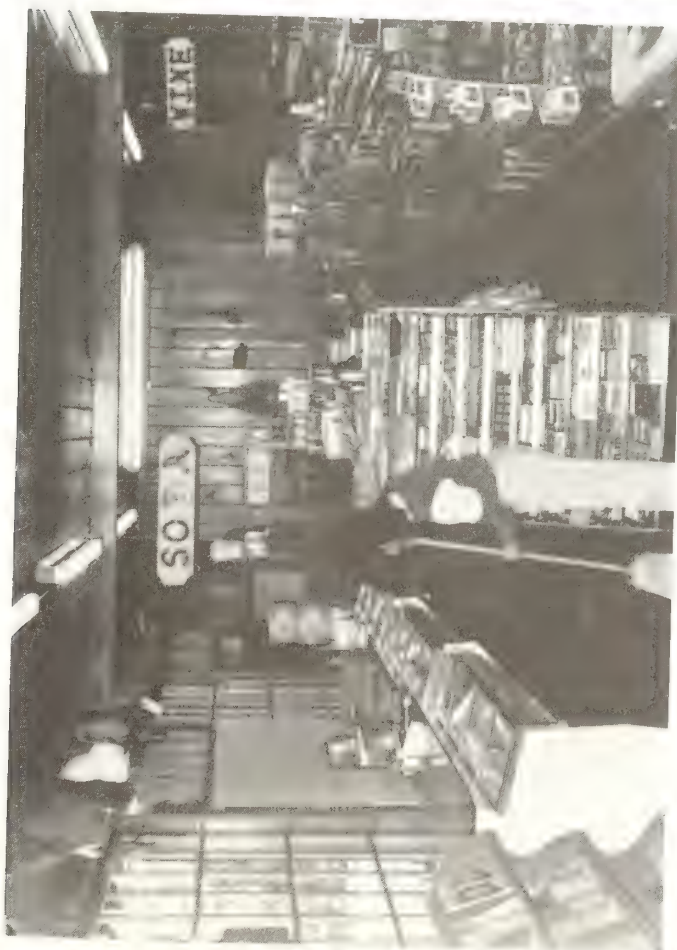
Figure 61 (right). Market, Lounge Interior (room 100) (5/86). The dark strip flooring, knotty pine paneling and an electrified gas lamp are visible in this view looking south towards the large multi-paned picture windows. The sequoia wood bar top and stone fireplace are at left. Notice intrusive character of ceiling hung heating unit. The absence of fluorescent lighting helps preserve this room's historic character.

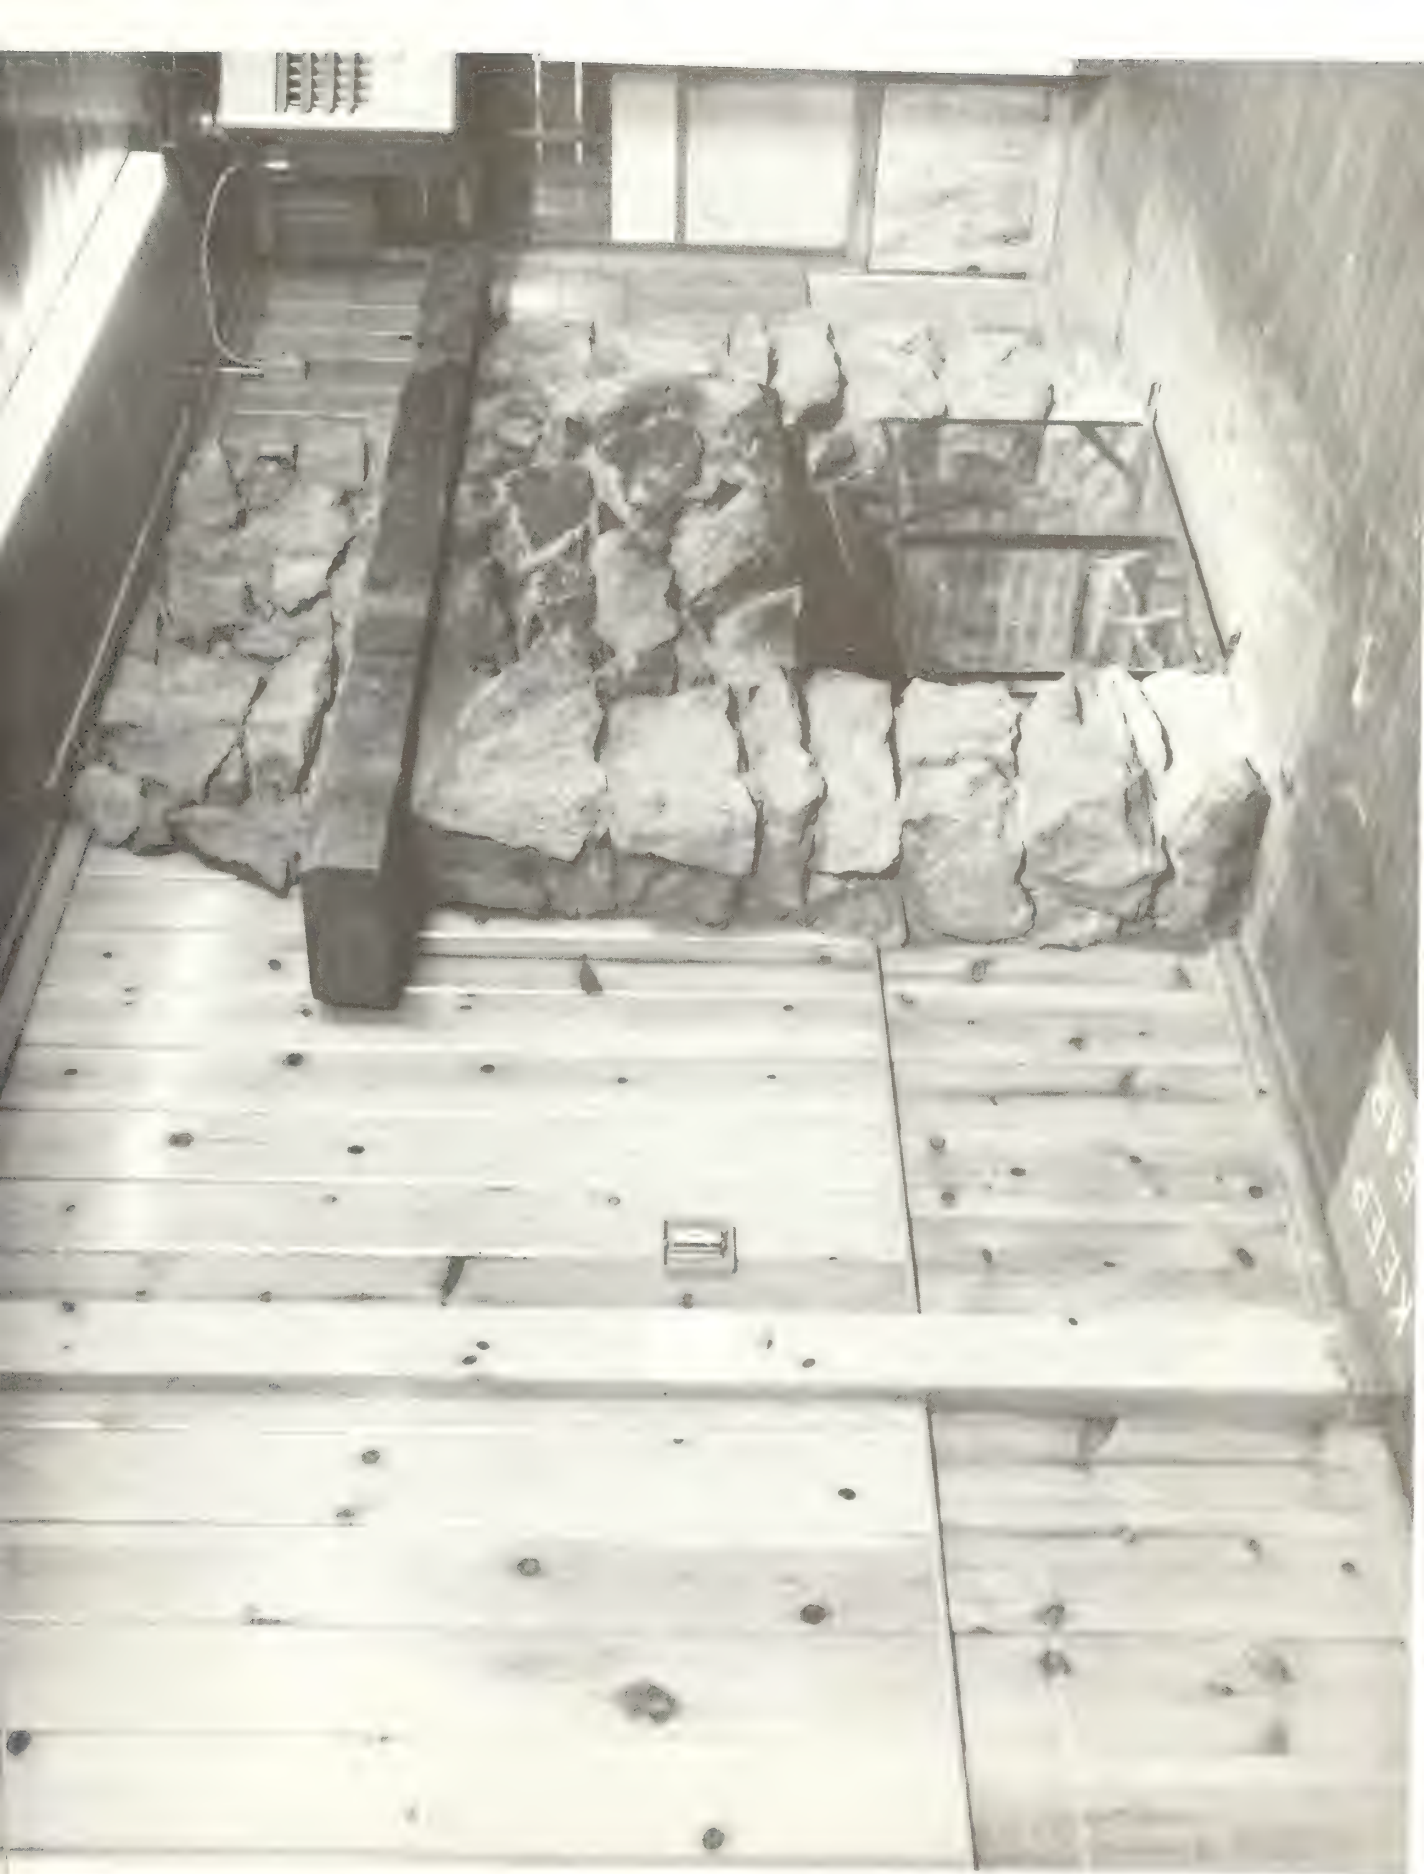
Figure 62. Market Fireplace (ca. 1983). This photograph pre-dates the 1983 remodeling of the Fireside Lounge (room 100)--the bar has yet to be installed here. A clear view is provided of knotty pine paneling, wainscot and the large stone fireplace. Also of note, is the southeast corner where plywood patches are present at the wainscot and floor due to material decay (see Appendix A for investigation findings in this corner). Notice, too, that 1975 fluorescent fixtures are still present and have not been replaced by the current electrified gas lamps (see figure 61). (HABS #CA 2148 B-7).

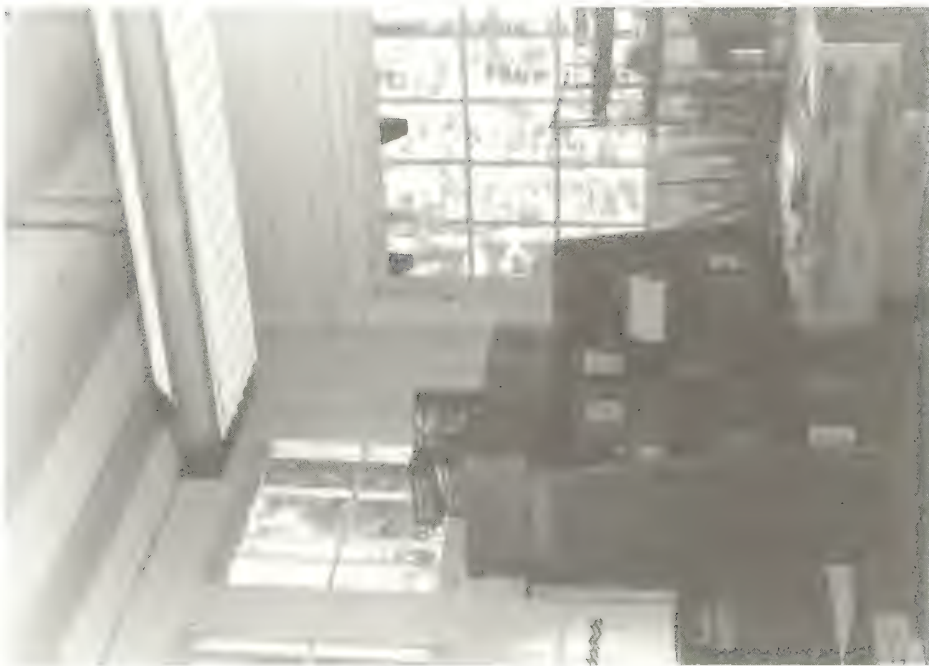
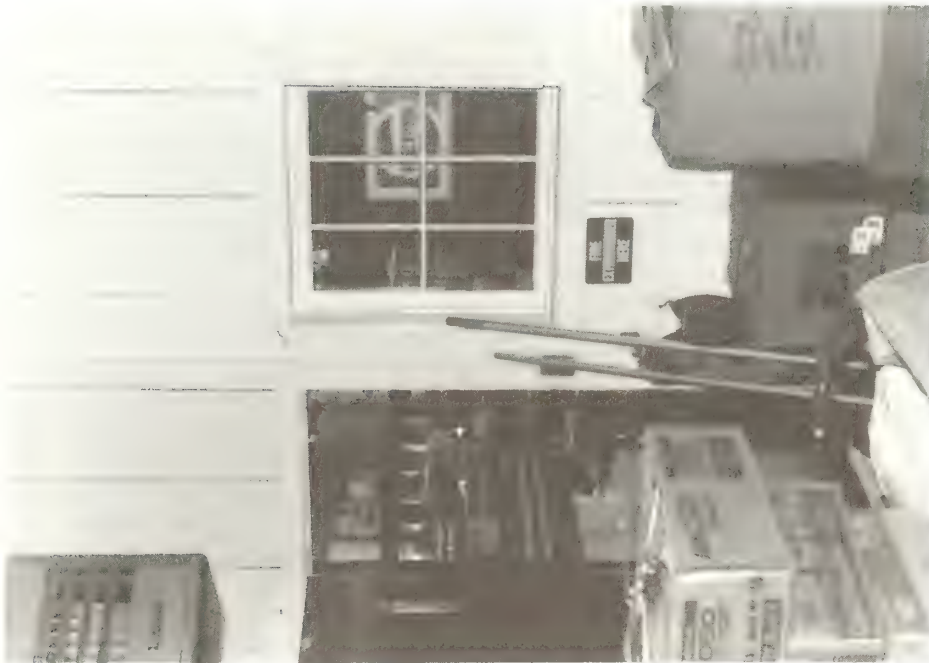
Figure 63. Market Room 102 (5/86). These views show the light and airy quality of room 102 with its array of windows and verticle paneling (3/8" x 11-3/4") painted white. The left view shows the doorway and window communicating with room 101 (the store). In the right view, the ceiling joists are exposed; fiberboard panels define the ceiling. Knotty pine was never installed on the ceilings in this room. Notice intrusive character of fluorescent light fixture.

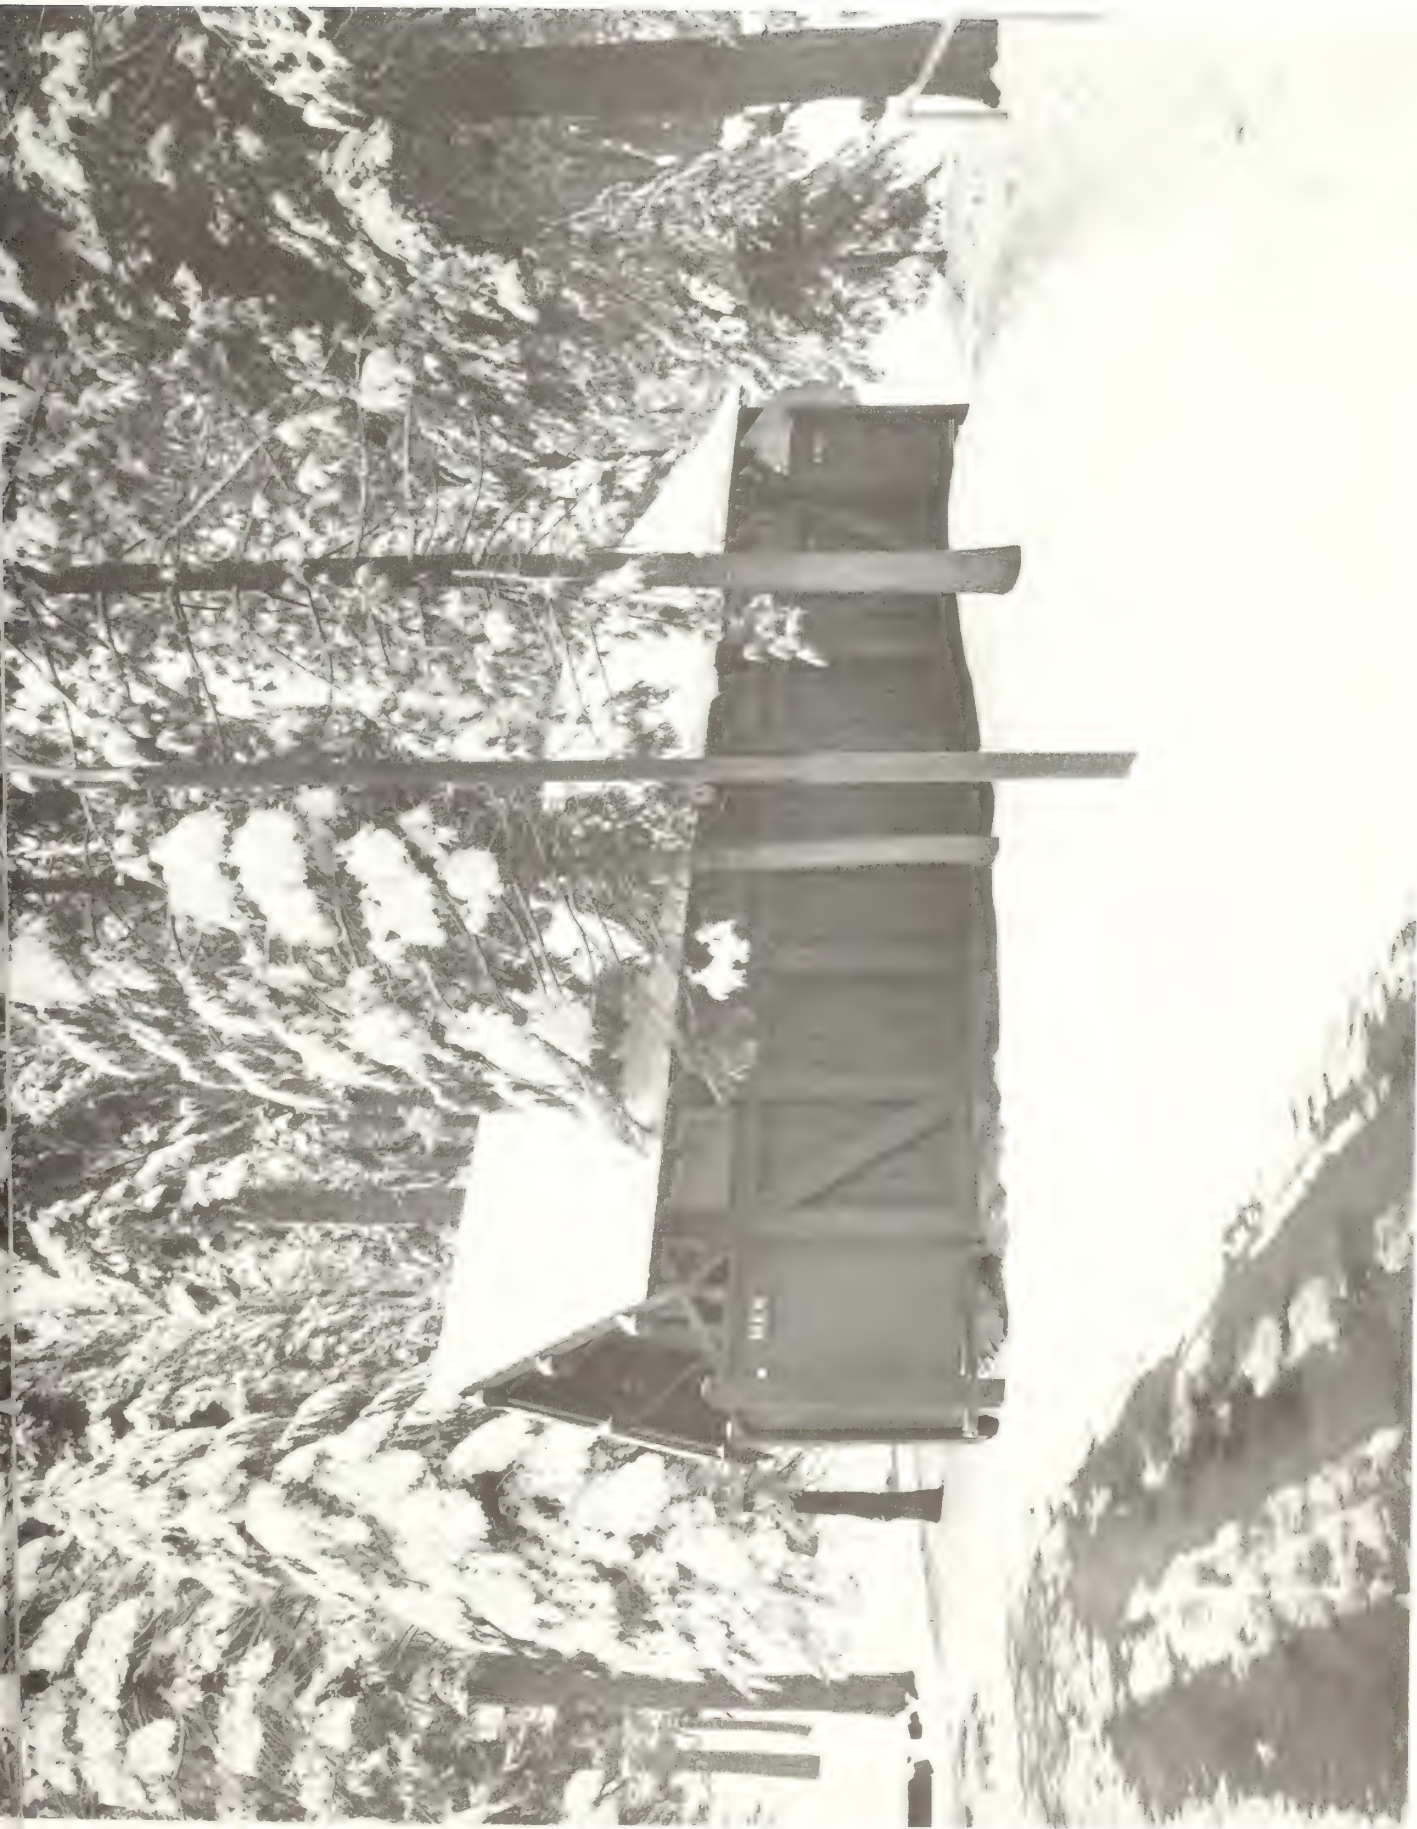
Figure 65. Comfort Station, View from West-Northwest (ca. 1983). Significant NPS-rustic style characteristics are visible here: stone foundation, exposed timber frame of 8x8s, shake siding, and braked gable roof. Note, sloped access walkways are treacherous this time of year. The overhanging roof provides good protection to entries at each end. (HABS #CA 2148 C-1).

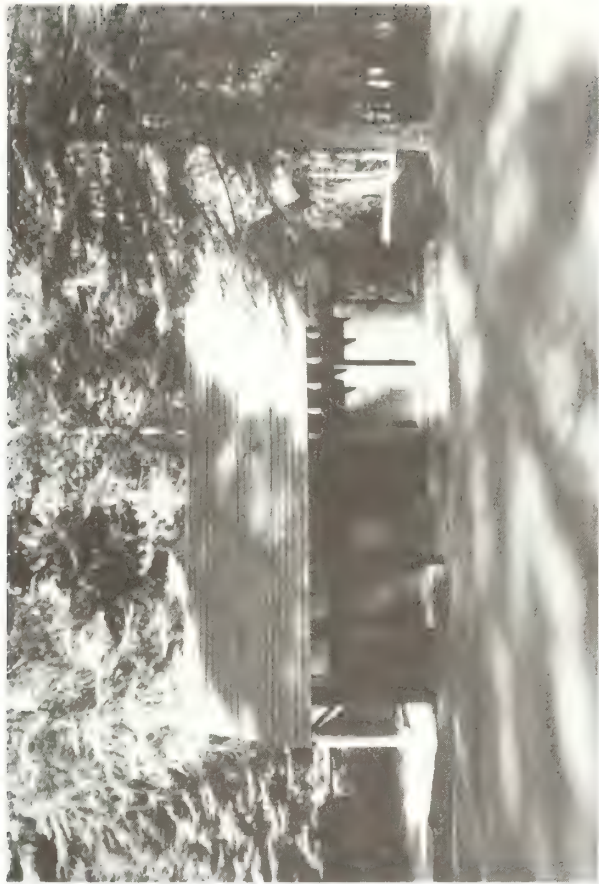
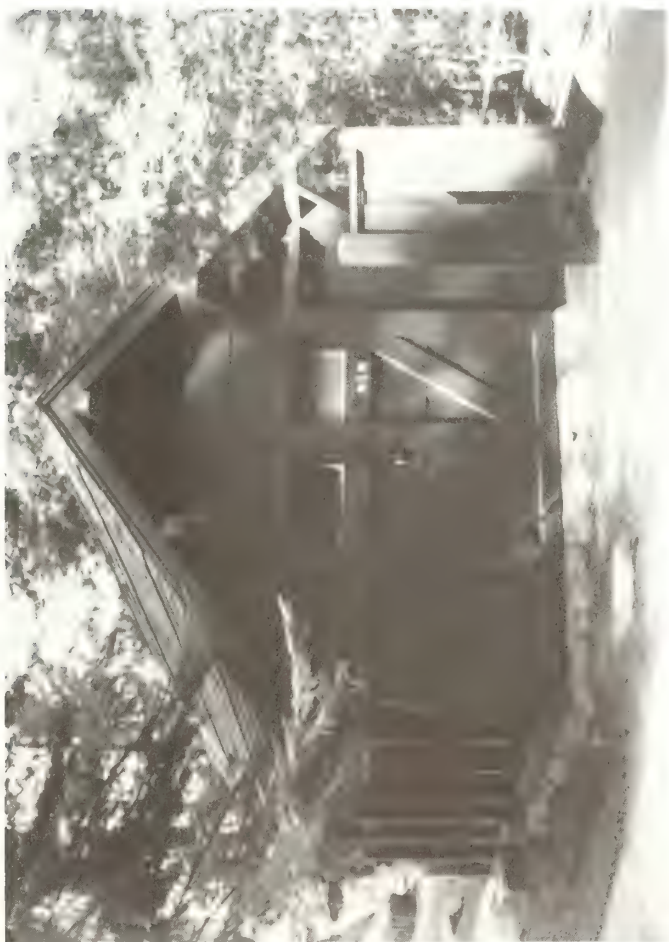
Figure 66. Comfort Station, North and East Facades (5/86). The wood shingled roof with double coursing is significant in these views. Notice, site grade piles up at foot of building from service road. Notice, also, inconsistent glazing pattern in view of men's side.

13) doors are aged and damaged	13) normal use	
14) lack of uniform window glazing (see figures 66, 93, and 94)	14) variety of window glazing patterns exist due to replacements at different times with non-matching glass

members to protect the wood from deterioration (see figure 66). See existing measured drawings (HABS) for documentary data.

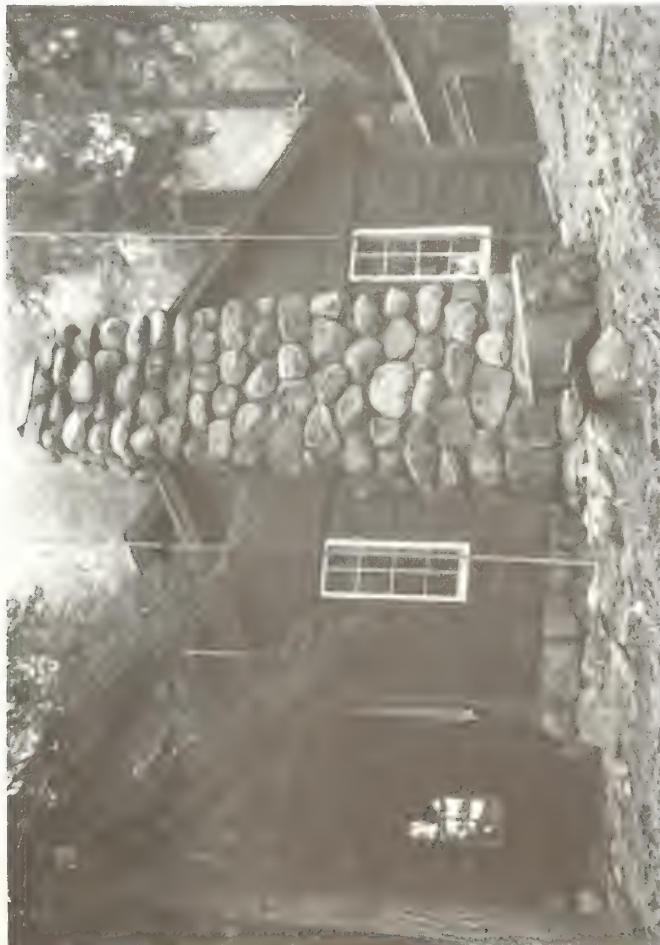
Figure 69 (right). Ranger Residence Site (10/86). Although on a hill overlooking the village (out of view, left) the residence is well blended and hardly noticeable in its natural landscape. The walkway, with stone and timber steps is in need of preservation.

Deficiency	Cause/Notes	Treatment
<u>Site Work and Landscape</u>		
6) negative surface water drainage towards house (see figure 96)	6) from hillside and build-up of natural fill	rebuild stone retaining wall and regrade immediate site to achieve positive surface water drainage; repair or replace gate and fence
7) natural debris build-up along west and south foundation (see figure 96)	7) historic stone retaining wall has collapsed	wooden elements and/or hardware; restore walk by removing soil build-up
8) gate loose at hinges and fence deteriorated (see figure 97)	8) same as #1	
9) walk has deteriorated (see figure 69)	9) same as #1, soil erosion

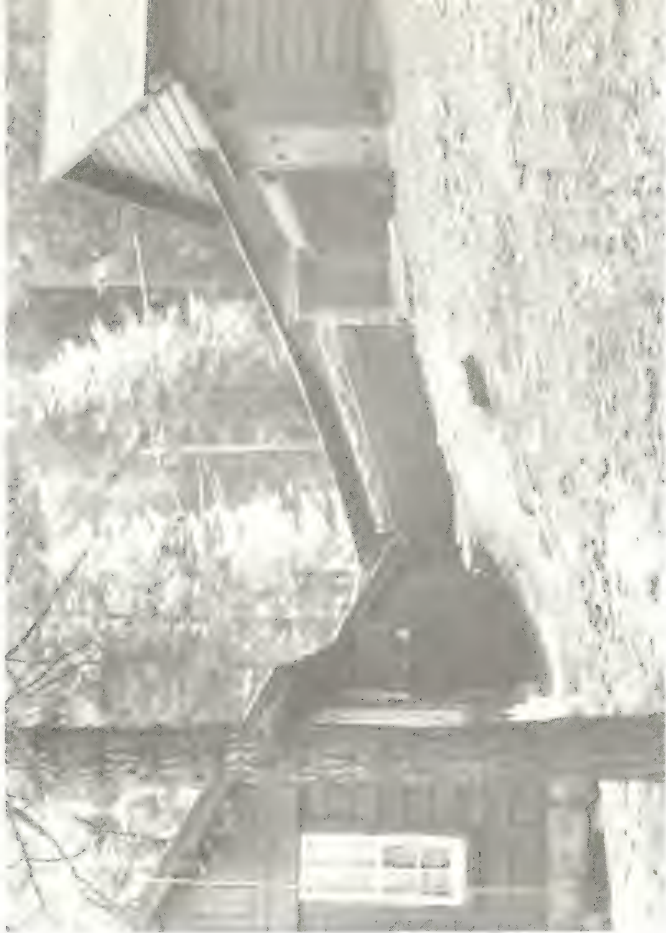
Figure 70 (left). Ranger Residence and Garage (10/86). This view, looking down at both structures, shows their spatial relationship--connected by the snow tunnel--and their stylistic, and material compatibility. The roof extension shed on the garage was added about 1984.

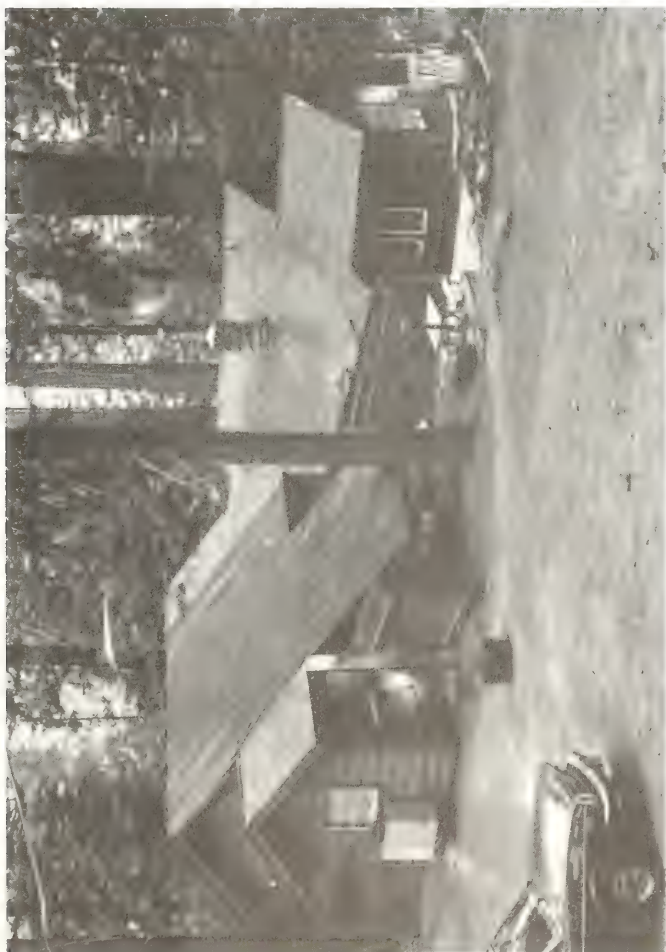
Figure 71 (right). Ranger Residence Snow Tunnel (5/86). This view shows the make-shift snow tunnel connecting the residence (at left) with the garage. The board-and-batten shed roof addition on the rear of the residence was built in 1953. The shed roofed closet attached to the rear of the garage houses storm sash/screen sash for the residence but was originally built in about 1953 to house LP gas tanks.

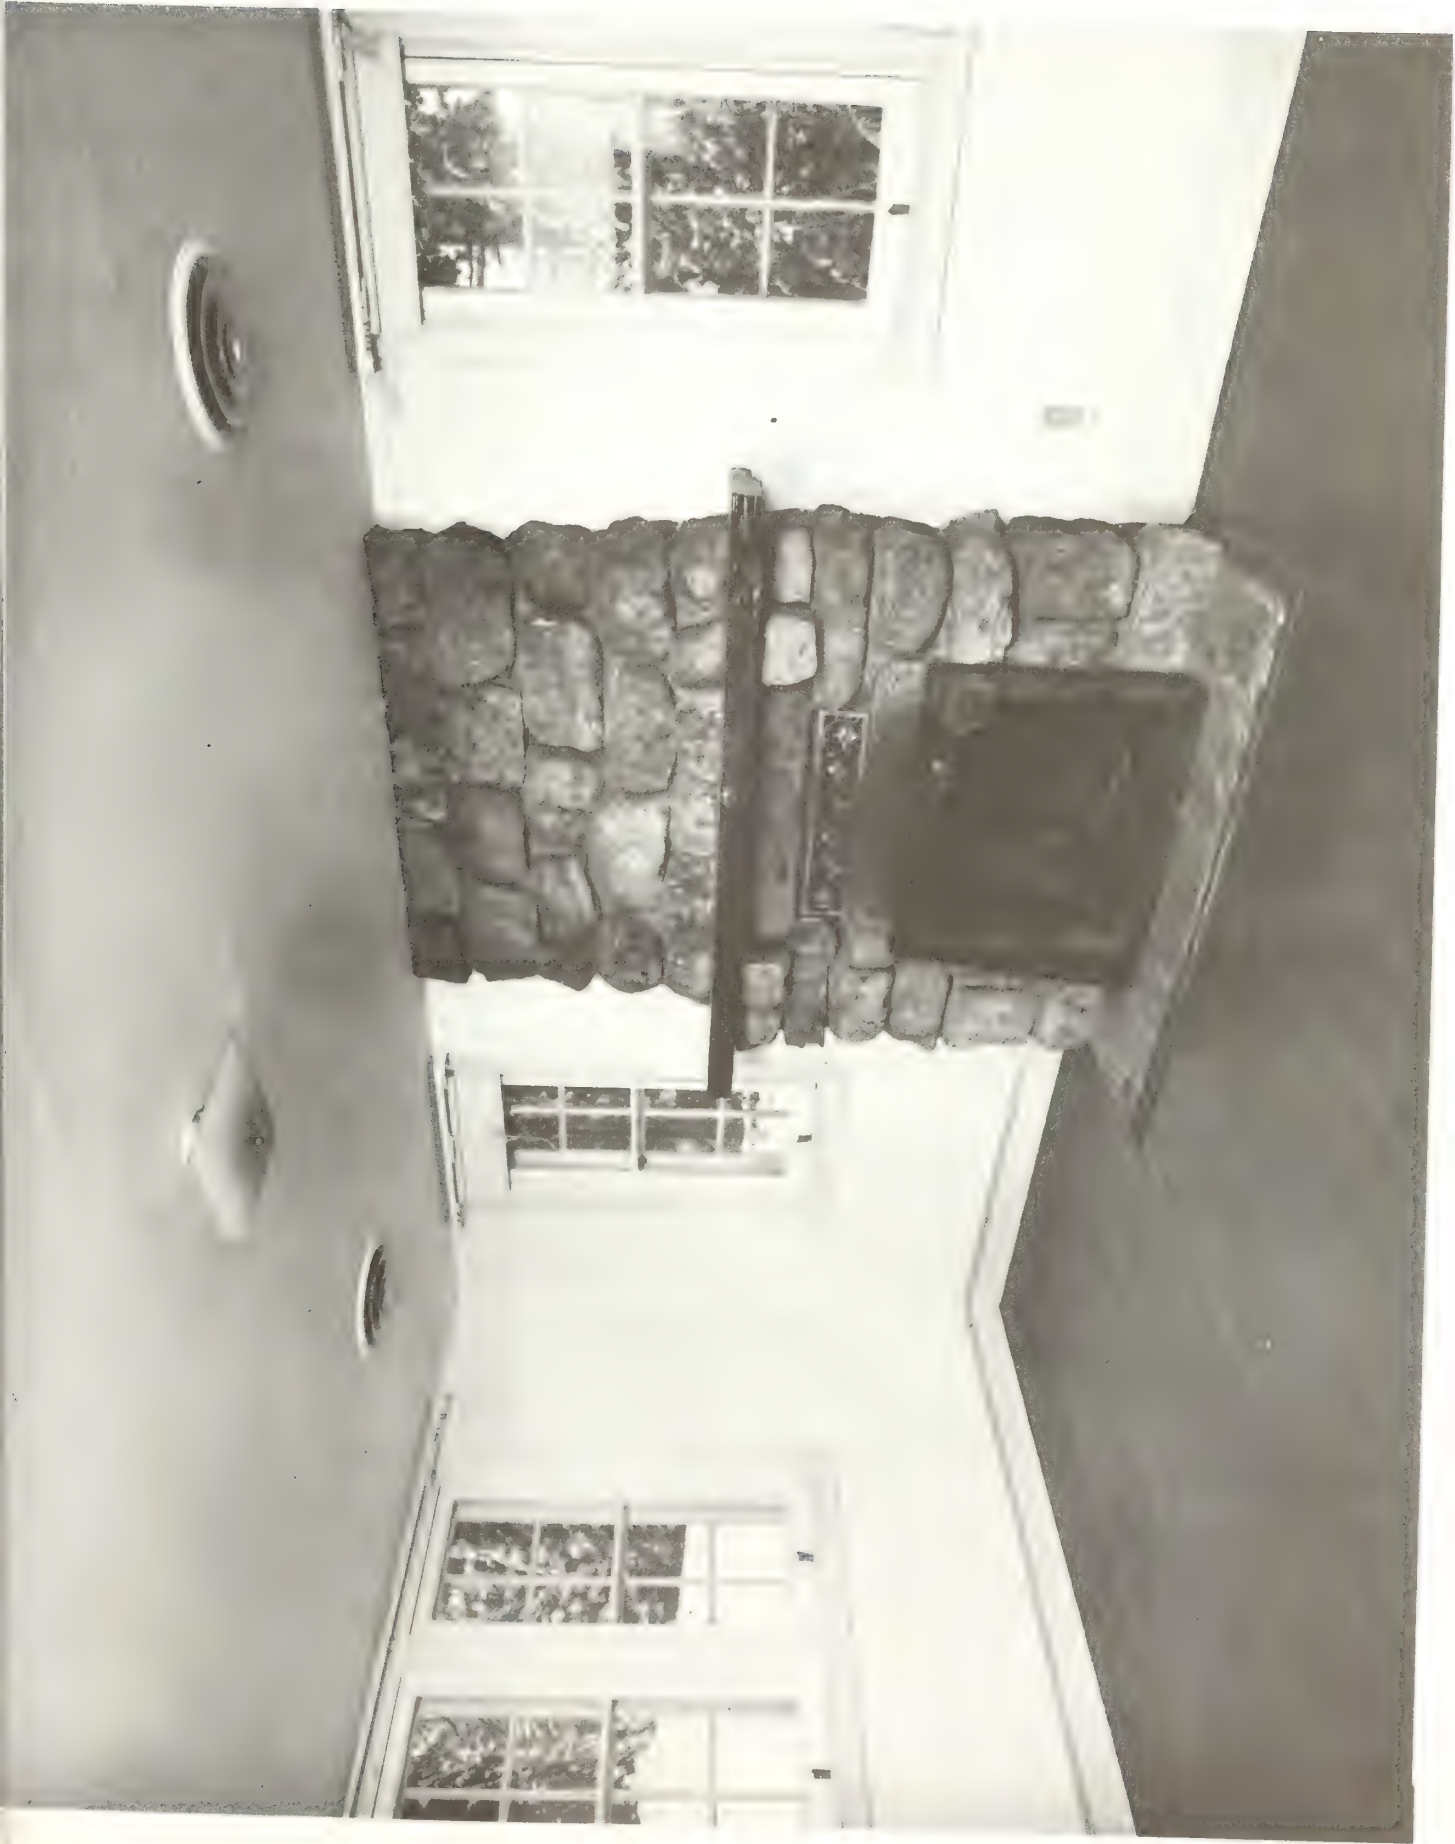
Figure 72. Ranger Residence Fireplace (ca. 1983). This interior view--prior to 1983 rehabilitation--shows the distinctive fireplace and dark stained pine flooring. Electrical work included grounded wiring in 1983. Except for the installation of a fire detection/warning system and GFCIs in the bathroom and kitchen, no interior work is recommended for the ranger residence (HABS #CA 2148 E-7).

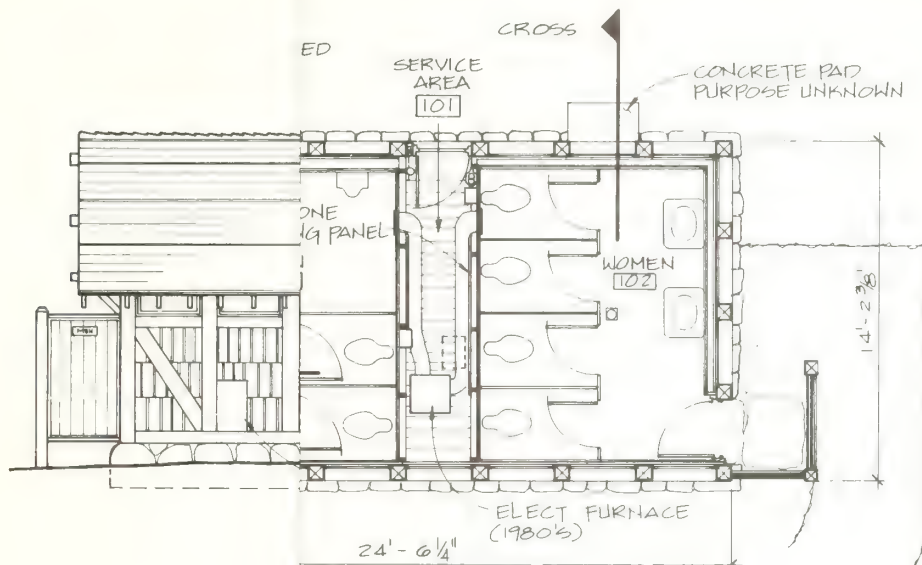
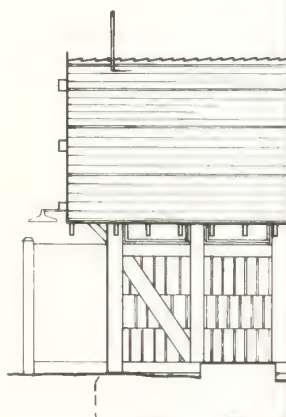
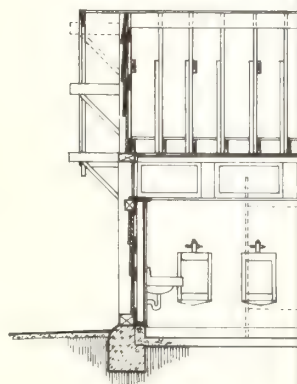
SOME ORIGINAL TRANSLUCENT RIPPLE GLASS REMAINS  
REPLACEMENT PANES DO NOT MATCH

EXISTING WOOD SHINGLE ROOF IS PROBABLY SECOND  
GENERATION BUT SIMILAR TO ORIGINAL GREEN  
PAINT IS MOSTLY GONE

BUILDING IS USED FOR ELECTRICAL & TELEPHONE  
SWITCHING STATION FOR OTHER STRUCTURES

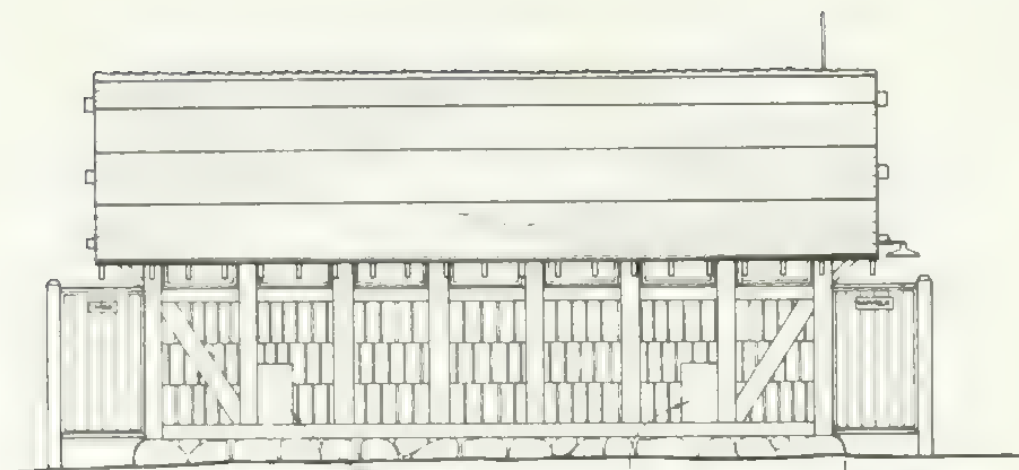
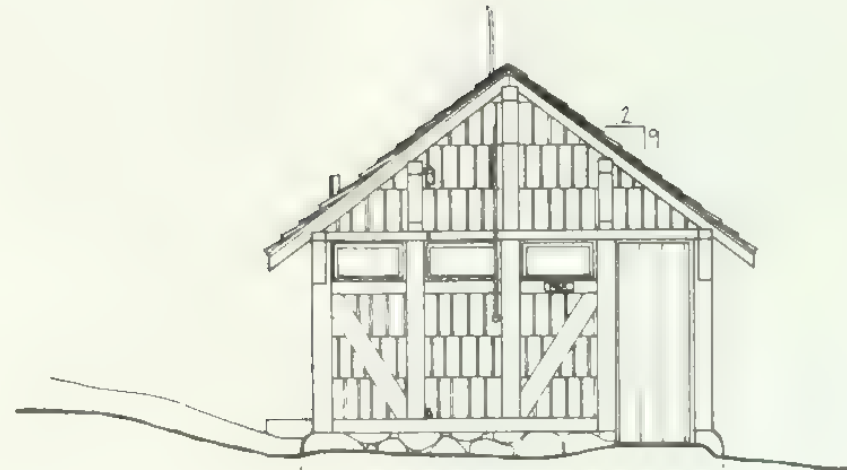
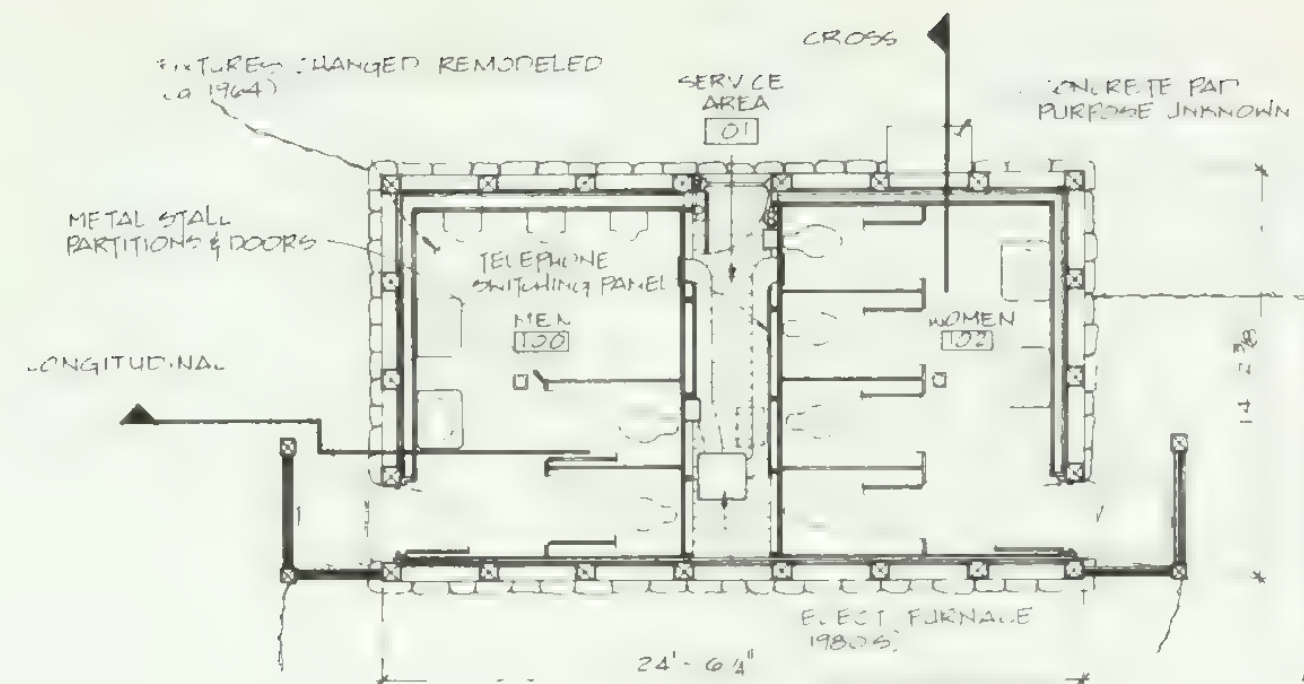
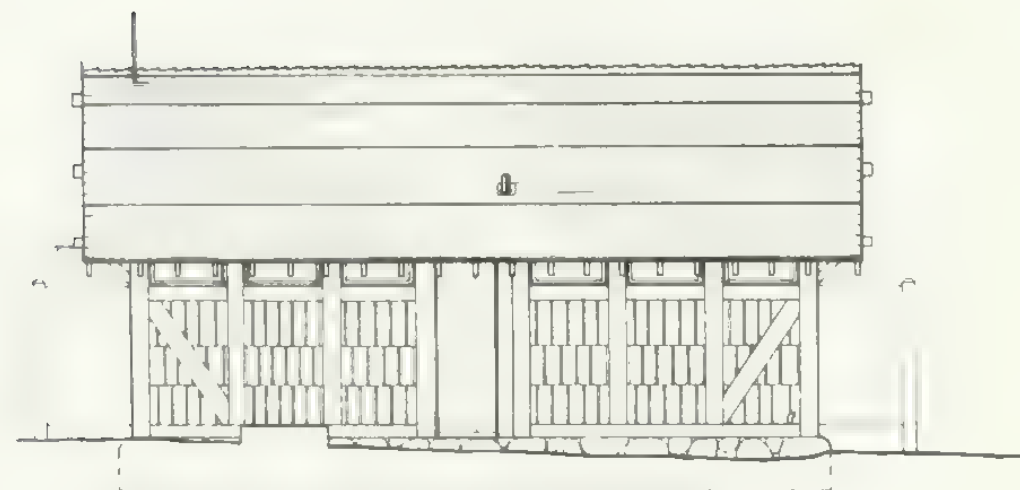
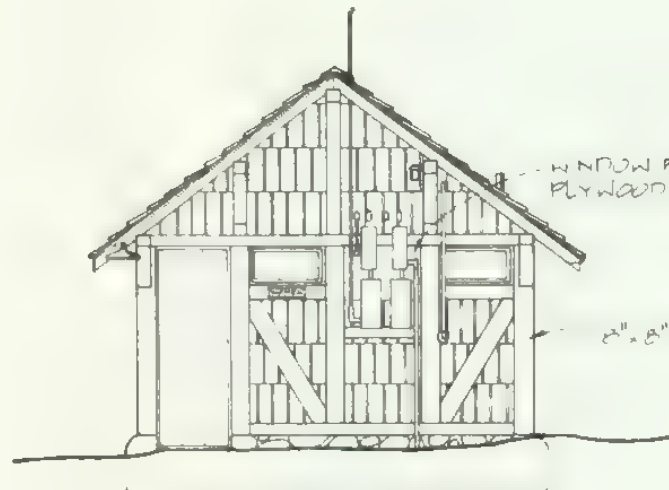
DESIGNED —	SUB SHEET NO. —	TITLE OF SHEET <b>COMFORT STATION PLAN, ELEVATIONS, SECTIONS</b>	DRAWING NO. <b>102</b>
DRAWN BY <b>FRANZ</b>			<b>25,000A</b>
TECH REVIEW —			PKG NO. <b>8</b>
DATE <b>2/01</b>			SHEET <b>8</b>
			OF 12

SOME ORIGINAL TRANSLUCENT RPPLE GLASS REMAINS  
REPLACEMENT PANELED DO NOT MATCH

EXISTING WEST SIDE ROOF IS PROBABLY 1960's  
GENERATION BUT SIMILAR TO ORIGINAL GREEN  
PAINT IS MOSTLY GONE

PLUMBING IS USED FOR ELECTRICAL & TELEPHONE  
WIRING STATION FOR OTHER STRUCTURES

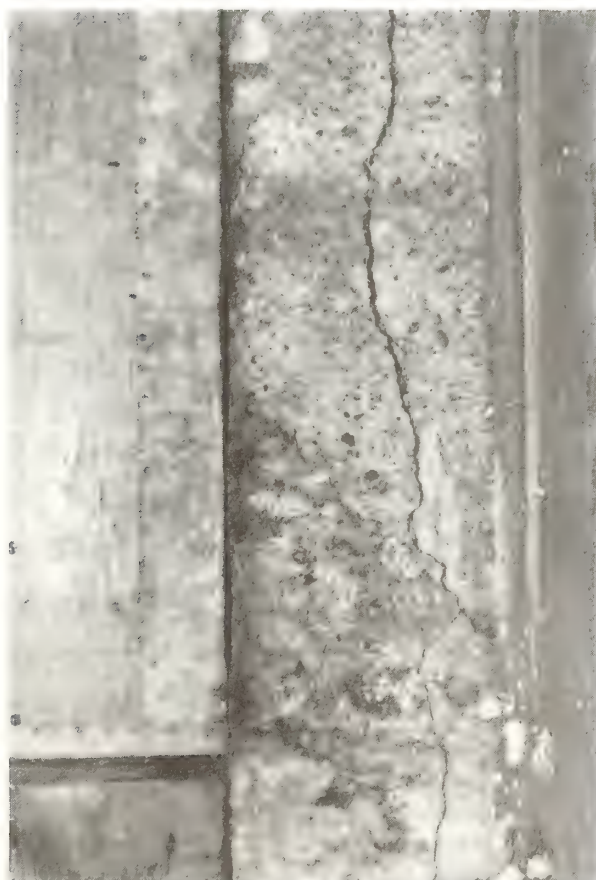
Figure 75 (left). Market - Rot at Southeast Corner (5/86). The site grade at this location produces negative drainage (run-off flows towards the wooden sill of the building). The result is near total loss of the 8x8 sill plate due to resulting rot, partial loss of the corner puncheon, and loss of shiplap siding (replaced with the plywood patch). These materials should be replaced and grading performed to facilitate positive drainage.

5) rotted and damaged wall sill beam at southeast corner of building 1 (see figure 75)	5) negative surface water drainage and natural build-up of grade next to building

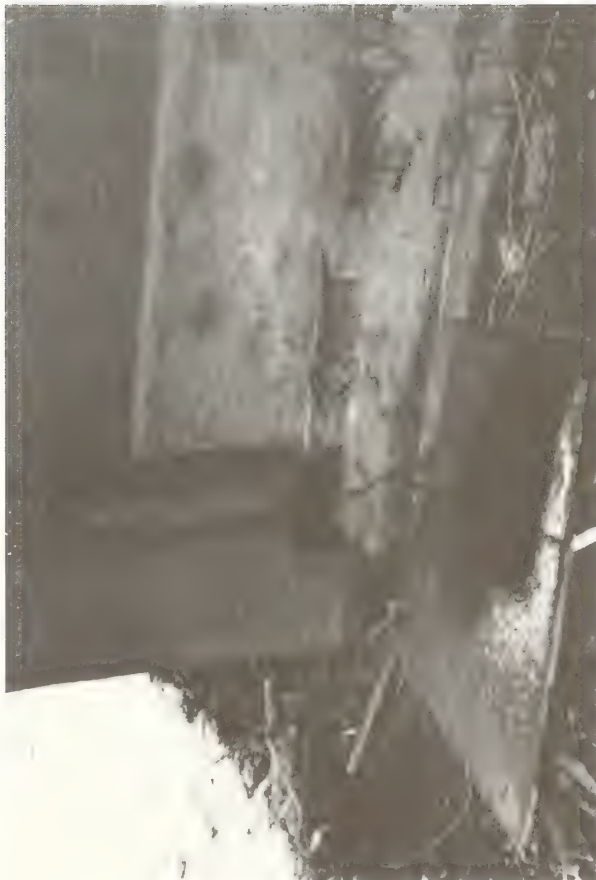
Figure 77 (left). Market - Shed Addition Roof (5/86). Uplifting of the aluminum panel roofing (1975) is indicative of its loosening and deterioration. Note also, some damaged and deteriorated rafter tails. The metal roof should be removed and roll roofing replaced. Rot should be cut out of rafter tails and voids filled with dutchmen patches, carpenters wood filler and/or epoxy.

Deficiency	Cause/Notes	Treatment
Roof and Chimney		
8) existing metal roof is failing and is an intrusion on historic appearance (see figure 77)	8) existing 1975 metal roof was temporary and has reached end of life expectancy	Remove metal roof and replace painted wood shake roof beneath, duplicating its historic appearance; install new felt roofing on 1938 shed addition and dormer; refinish hips, valleys and chimneys; repair or replace deteriorated and damaged rafter tails; close holes at soffitt

9) some rafter tails deteriorated and damaged <sup>4</sup> (see figure 77)	9) exposure to elements	
11) bats and other pests have access to attic	11) holes at soffitt

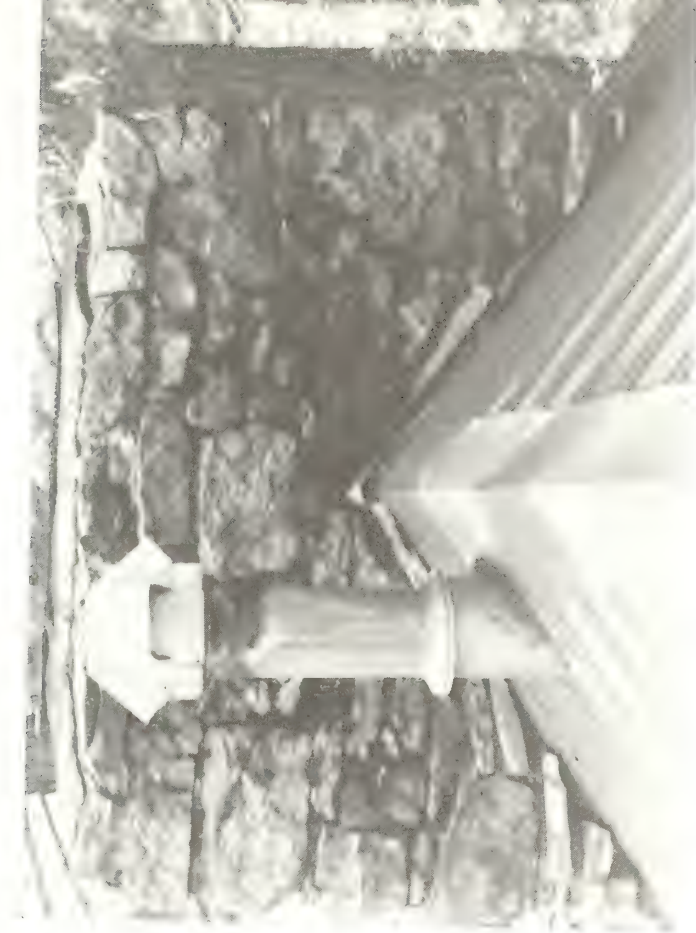
Figure 78 (right). Market Roof and Chimney (5/86). The chimney counter-flashing probably dates to 1930 and needs replacing. The fireplace chimney utilizes a heavy-gauge screen as a spark arrestor. There is no rain guard. The chimney should be cleaned out, a metal flue lining installed, flashing replaced as part of a comprehensive reroofing, and a compatibly designed spark arrestor/rain guard installed.

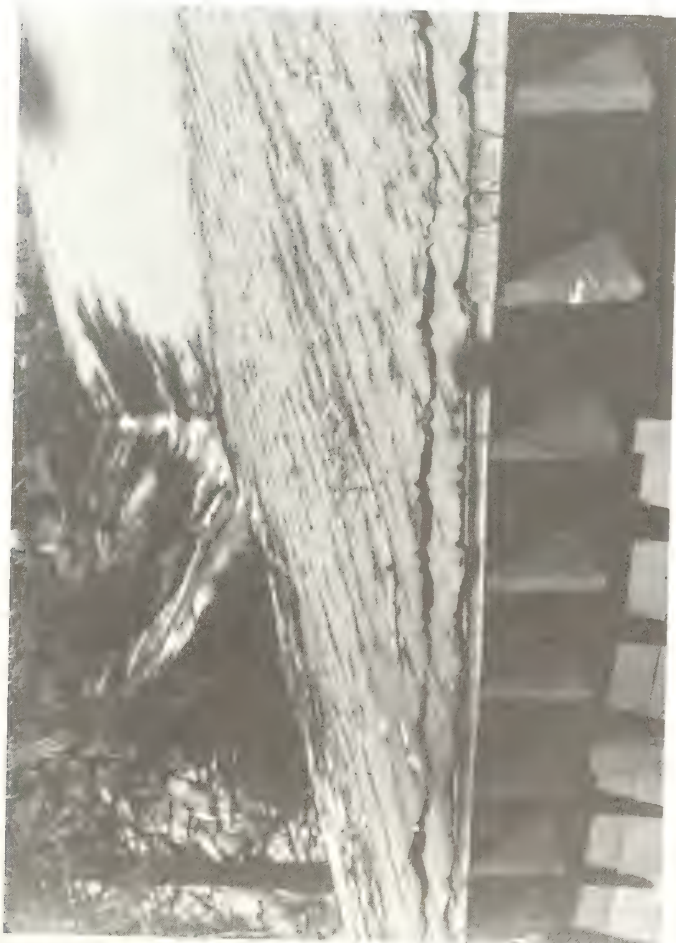
Figure 79 (left). Market Fixed Sash (5/86). A large percentage of the market's facades is single pane glazed. This is a major source of heat loss. Installing an additional and similar multi-paned 'storm' sash on the interior side of these windows would have little visual impact from the exterior and would be cost effective, over time, in terms of energy conservation.

Deficiency	Cause/Notes	Treatment
Doors, Windows, Fixtures, Equipment, Furnishings		
20) doors and windows <sup>8</sup> source of heat loss (see figure 79)	20) poor fit, damage, no dual glazing, no storm sash, no weatherstripping	Rehabilitate all doors and windows necessary for use and include caulk, weatherstrip, new storm sash and security/exit hardware.

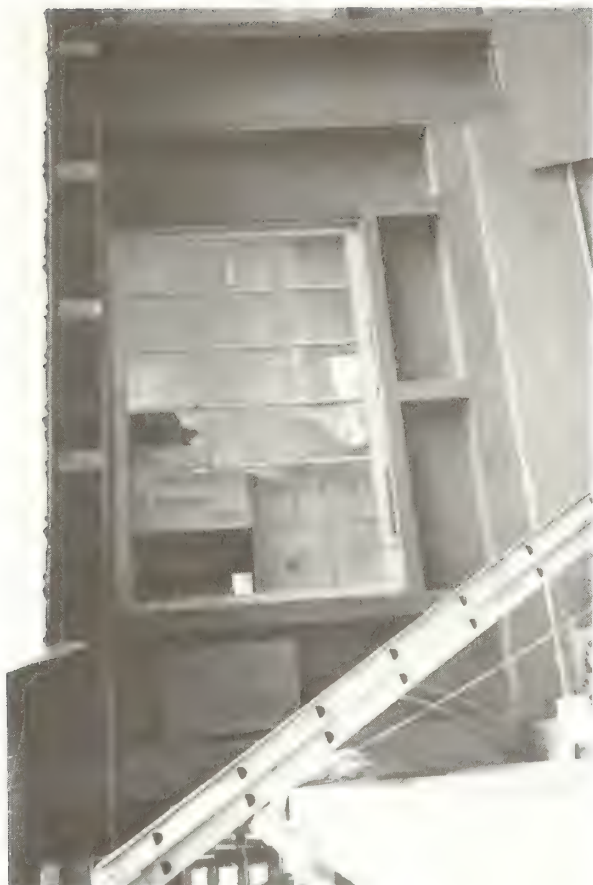
Figure 80 (right). Market Broken Window (10/86). This is the easternmost window of the north facade (part of the 1938 addition). This photograph was taken after the plywood covering was removed to enable examination. Note broken sash and glazing which should be repaired.

21) doors and windows worn and damaged, certain doors and windows inoperative (see figures 80, 81 and 82)	21) doors and windows are affected by age and use, some are plywood covered or are secured in the closed position for security reasons
